Manhole Inspection Summary

Manhole # S15KK1086MH

Record Plat: **15KK1** Node: **086** Status: **New Manhole (Not in GIS)** Insp Date: **12/5/06 12:00 AM**

Location Address: **4567 DERBY MANOR DR** Cross Street: **EDGECOMBE CIR**

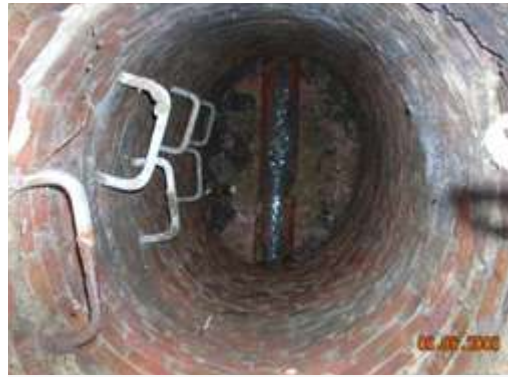
Top View

Corroded steps. Evidence of surcharge - Bench debris. Channel debris.

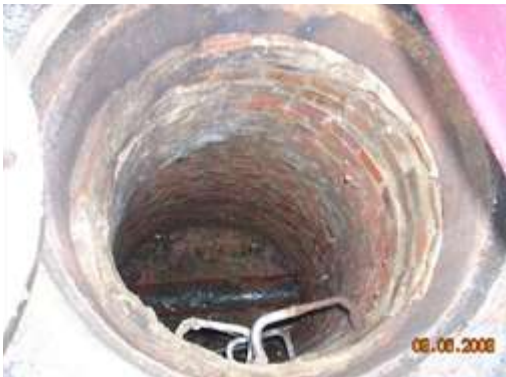
Defect

Frame leaks. Adjustment deterioration and infiltration. Corbel and Barrel infiltration - other side.

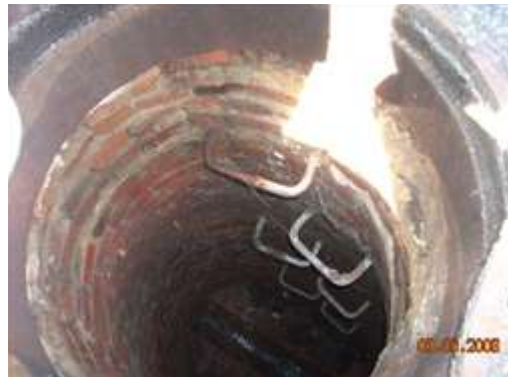
Defect

Frame leaks. Adjustment deterioration and infiltration. Corbel and Barrel infiltration.

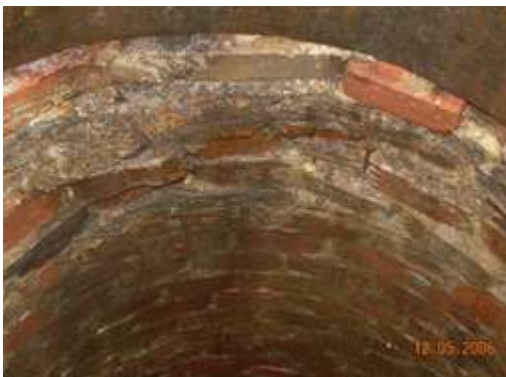
Defect

Frame leaks. Adjustment deterioration and infiltration.

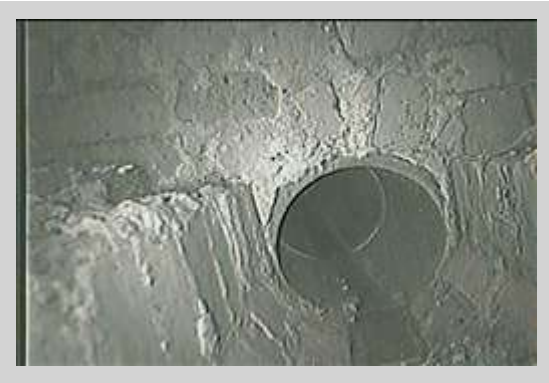
8 in. Circular Gravity Sewer Pipe Out @ 12 O'Clock

Infiltration: **Evidence** Pipe Seal Cond: **Unknown**

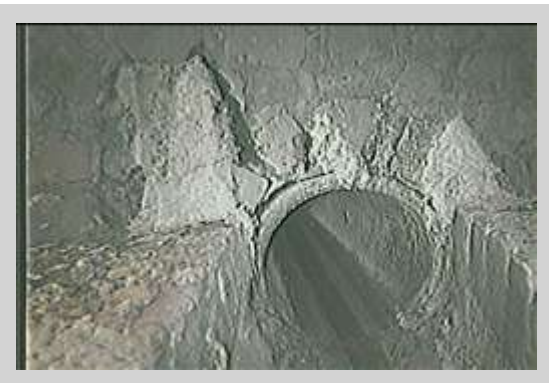
8 in. Circular Gravity Sewer Pipe In @ 6 O'Clock

Barrel deterioration and infiltration.

Infiltration: **Evidence** Pipe Seal Cond: **Cracked**
